PLUS
PAPAYA
Dental X-ray Imaging system

Panoramic
Cephalometric
Tomography

New Concept / Multi-function Imaging System, PAPAYA PLUS

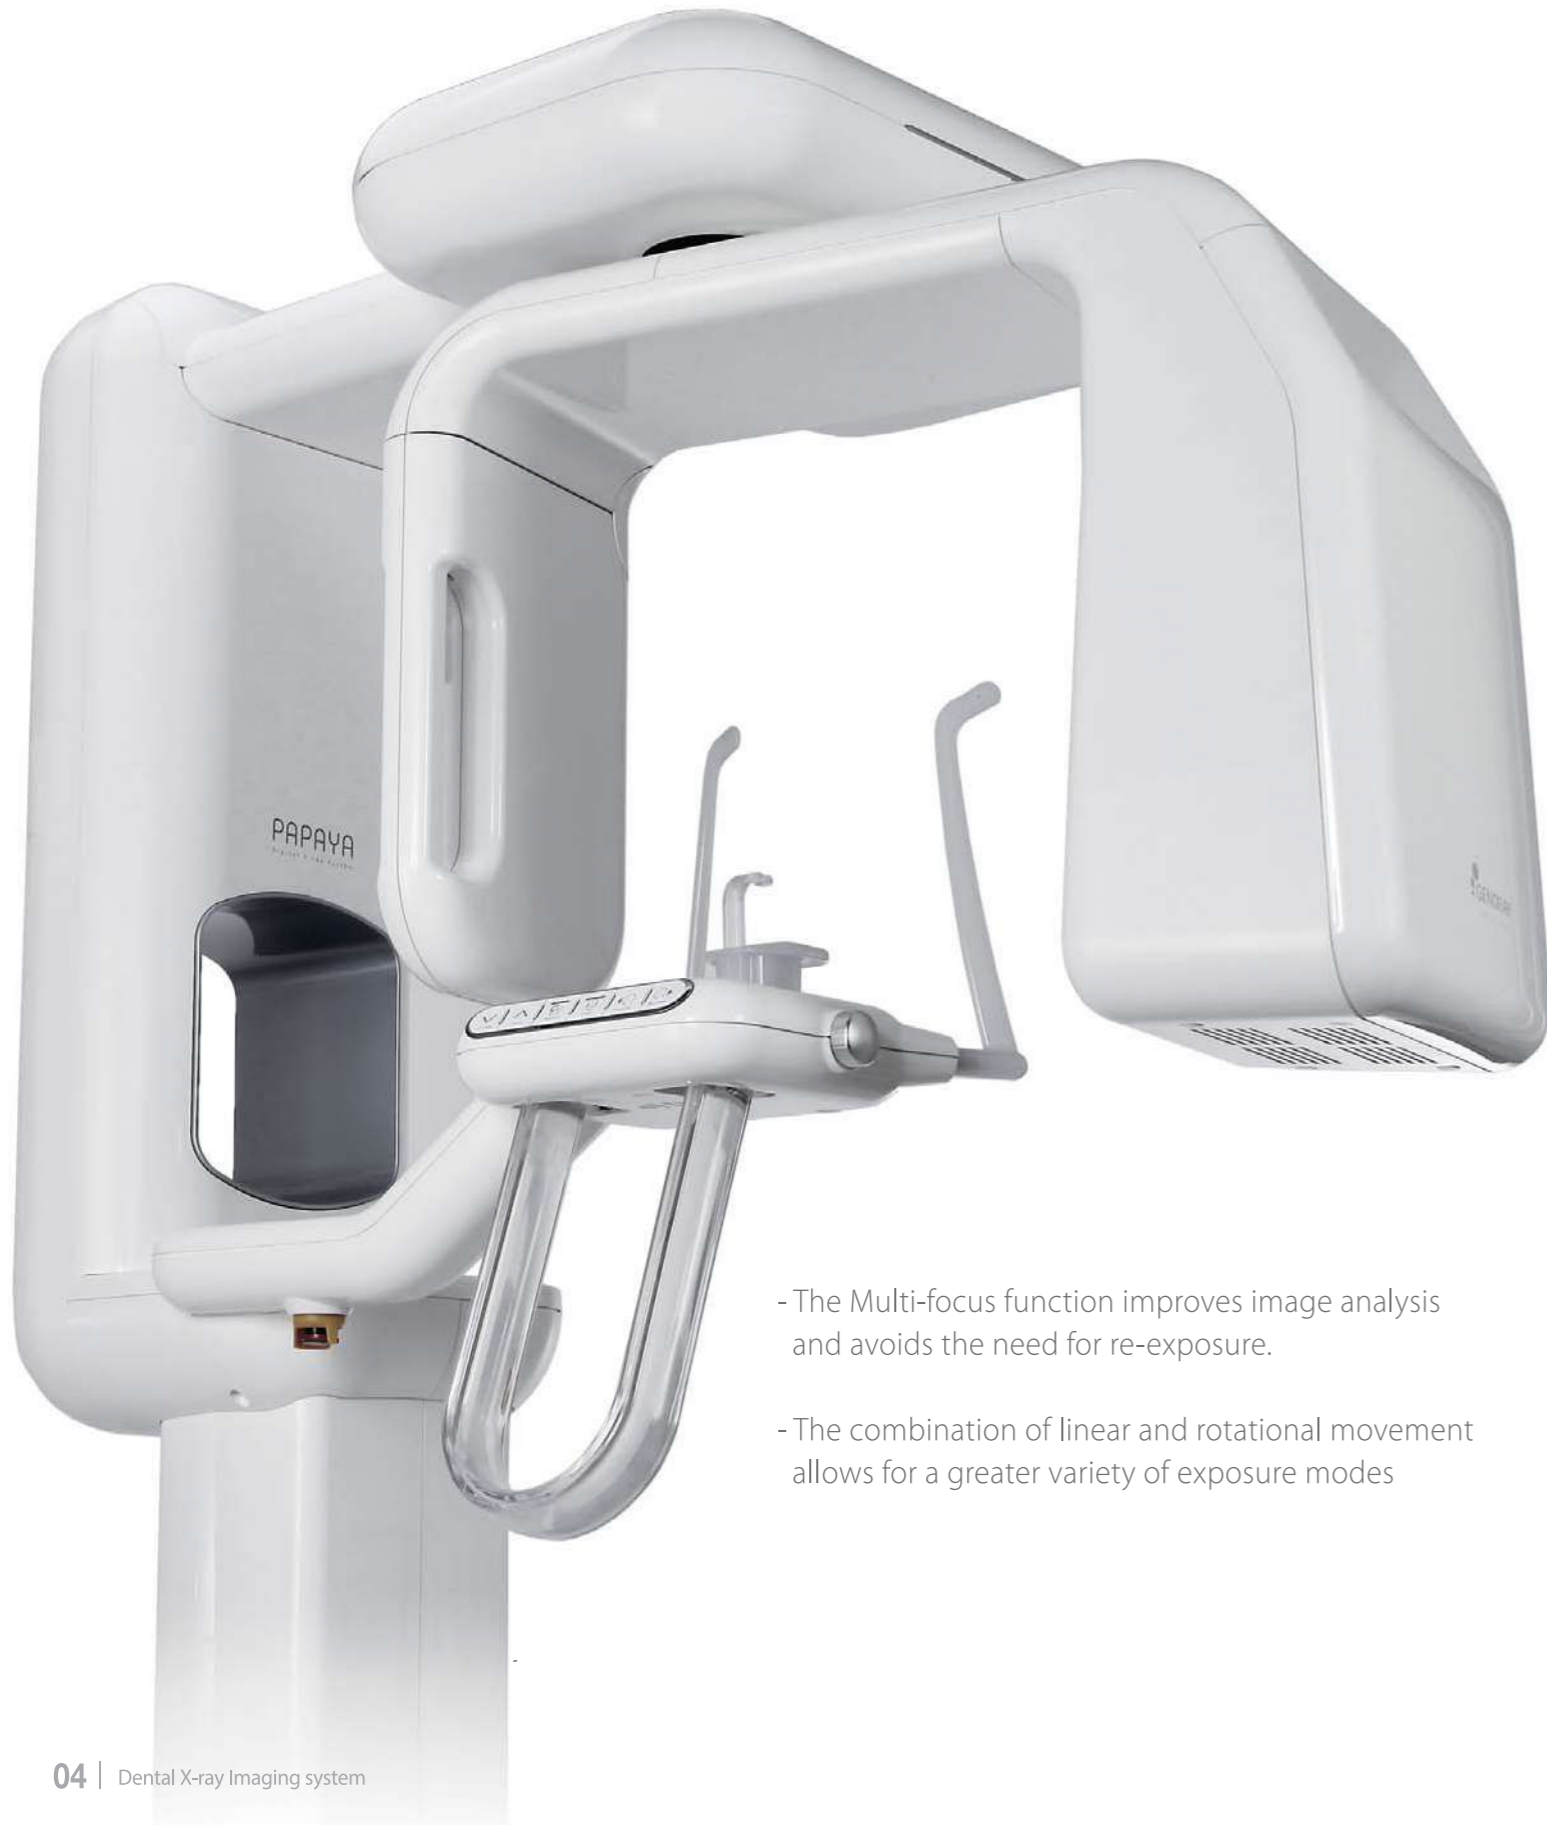
High Resolution Panoramic Image

- The Multi-focus function improves image analysis and avoids the need for re-exposure.
- The combination of linear and rotational movement allows for a greater variety of exposure modes

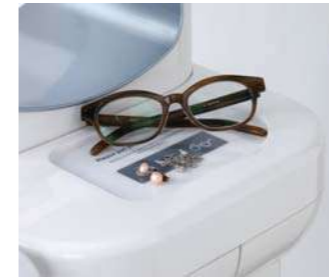
Papaya: This smart design will allow for easy, fast setting and installation. Not only that, its compact design requires minimum space and is easily accessible for your patients.

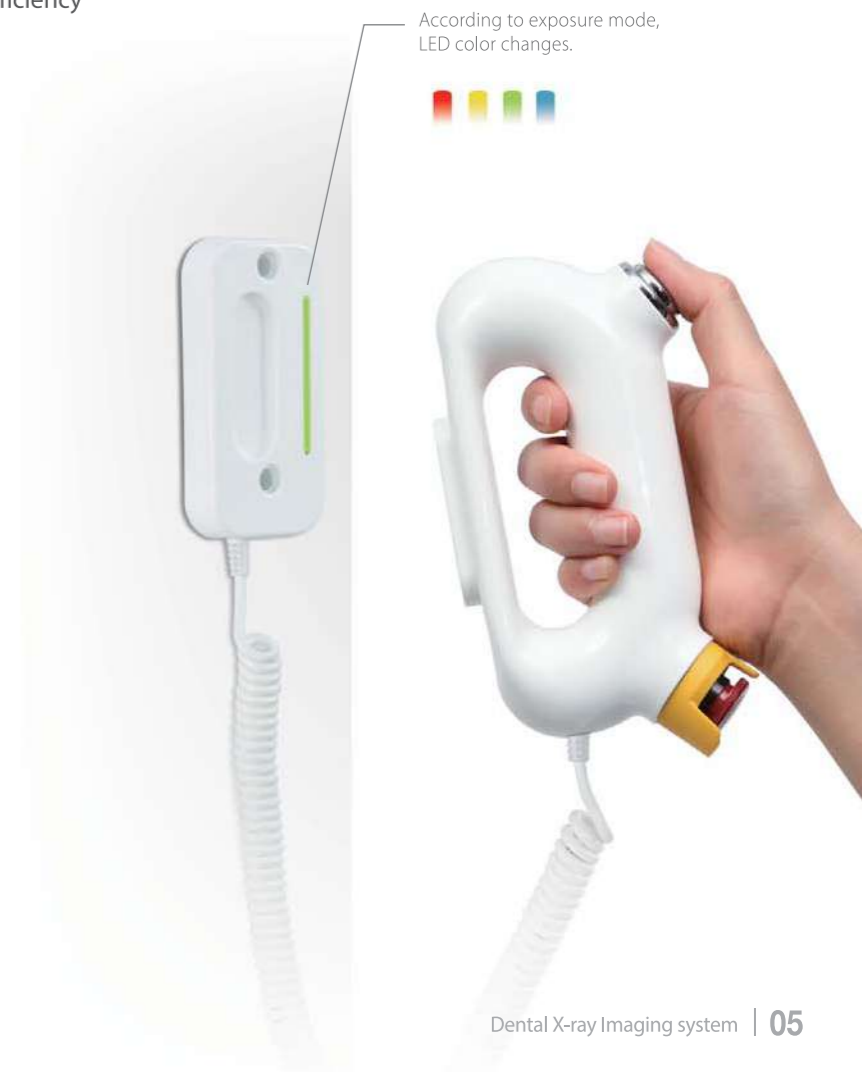
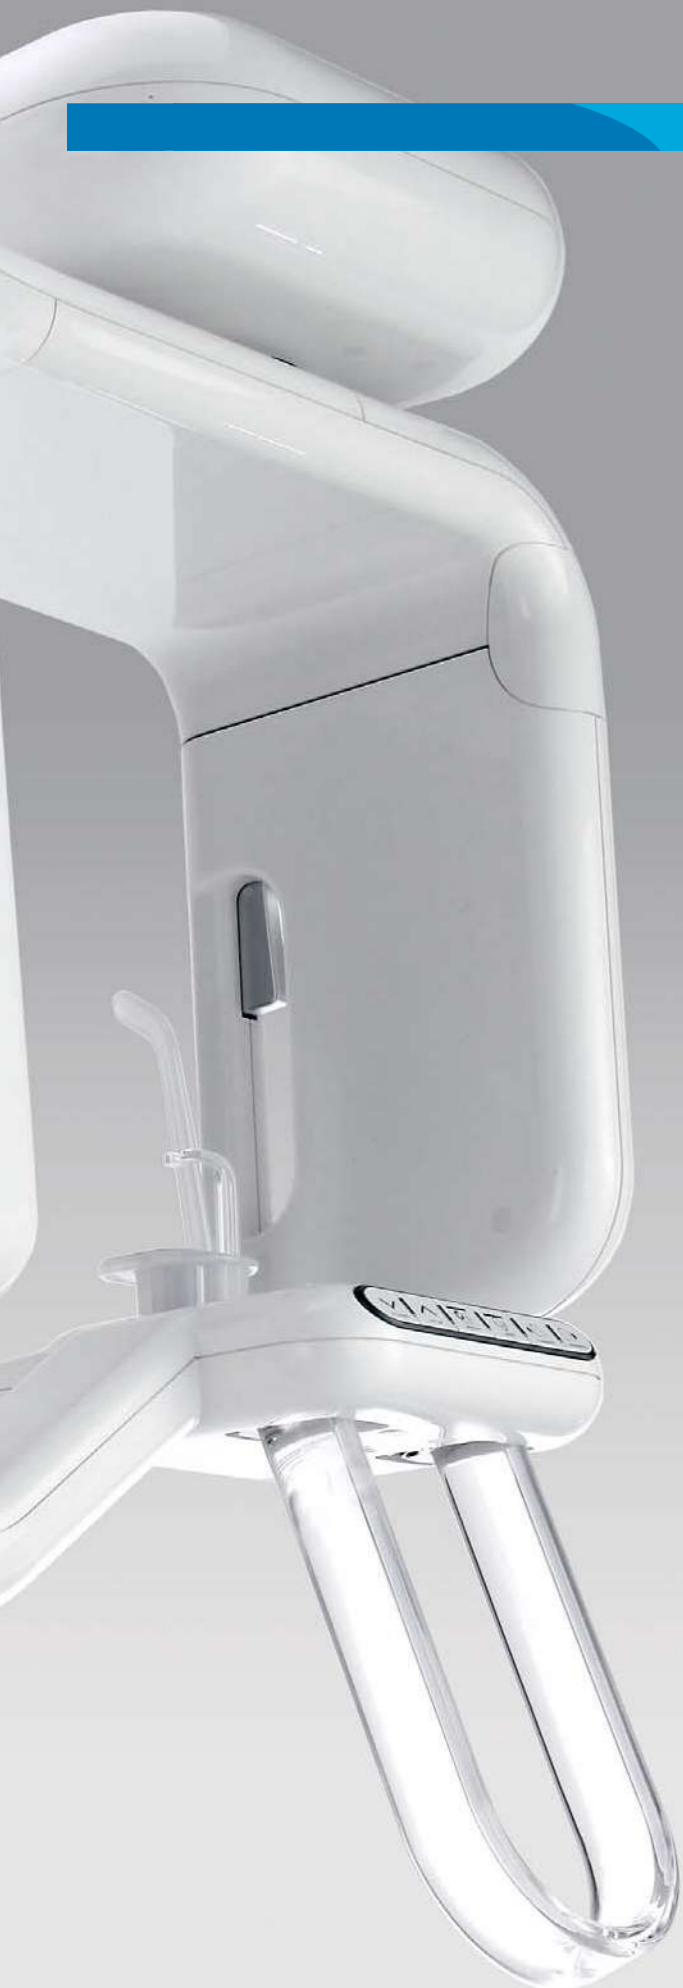
Wheelchair accessible

According to exposure mode, LED color changes.

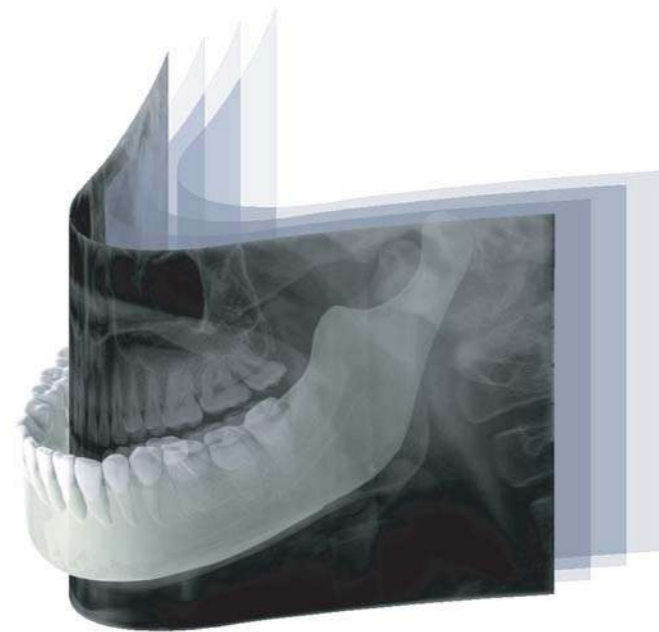
Multi-Focus Function

Multi-focus function is able to overcome operator's mistake from patient's faulty positioning and re-exposing X-ray. By reconstructing image with software way, the panoramic images layer can be corrected by multi-focus function.

Only one scanning and acquired multiple image with maximum of 5 slices. It's slice interval can be varying 0.1 to 5mm.

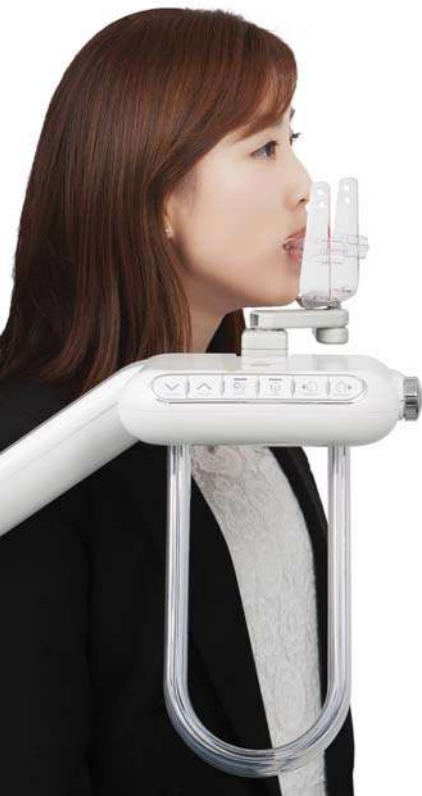
Dental Cross Sectional View

PAPAYA CUST is in a 3D imaging function that provides cross-sectional information for implant preparation.

- Complements the panoramic image, and provides a tomographic image required for implant planning.
- When planning the implant, CUST images help the patient understand the procedure.
- PAPAYA with CUST function is economical compared to CBCT.

- PAPANAYA PLUS provides true 3D imaging on the panoramic system.
- High image quality due to statistical reconstruction technique.
- 3D image has 256 cross-sectional slices having 0.195mm thickness and has FOV 5x5x10.3cm.

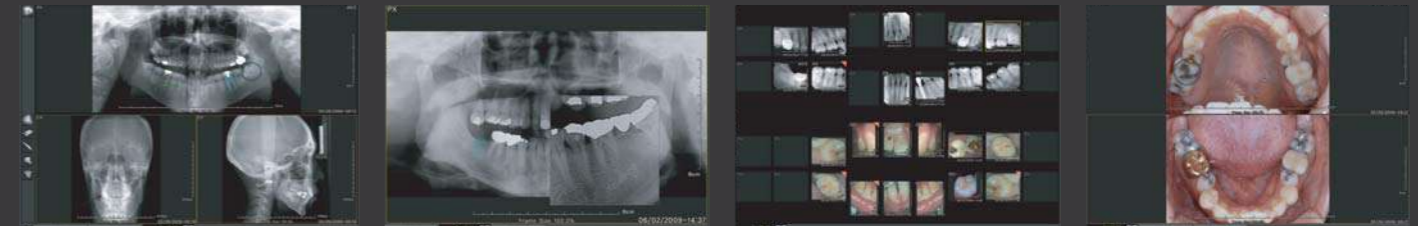
PAPAYA operation software

PAPAYA exposure modes are prepared and initiated using clear step by step pictorial software.
